# PARAJET TECHNICAL ADVISORY BULLETIN

## OCTOBER 2022 - UPRATED FUEL CAP REPLACEMENT

PJ-P-10088 : Fuel Tank Cap

fitted to Parajet Maverick, Zenith and Volution 3 paramotor airframes.

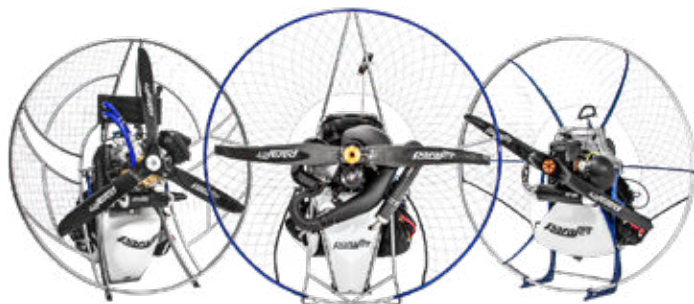
Parajet are aware of an extremely small number of cases where the fuel cap has not allowed sufficient air to enter the tank during use, creating a vacuum inside the tank and starving the engine of fuel.

Repeated exposure to excessive pressurisation without correct ventilation can lead to tank degradation, including deformation, splits, and tank ruptures.

An investigation was opened and following an immediate full batch inspection and review, our design engineers identified the OEM valve component at fault and have issued an in-house upgrade to better allow airflow to be drawn into the fuel tank at the optimum rate, avoiding vacuum build-up and fuel starvation to the engine.

This updated fuel cap is a direct replacement and should be immediately fitted to the tank and the old cap discarded.
