# PARAJET TECHNICAL ADVISORY BULLETIN

## OCTOBER 2022 - UPRATED FUEL CAP REPLACEMENT

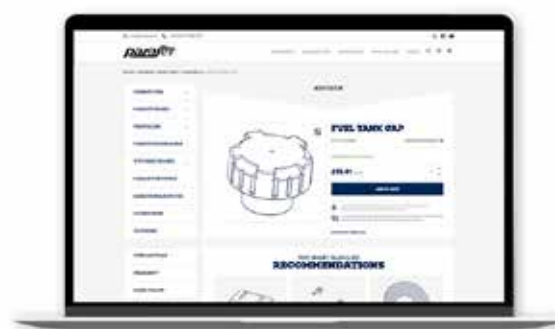
An investigation was opened and following an immediate full batch inspection and review, our design engineers identified the OEM valve component at fault and have issued an in-house upgrade to better allow airflow to be drawn into the fuel tank at the optimum rate, avoiding vacuum build-up and fuel starvation to the engine.

This updated fuel cap is a direct replacement and should be immediately fitted to the tank and the old cap discarded.
