PARAJET SAFETY ADVISORY BULLETIN

FEB 2026 - SOFT LINK CONNECTION AND MAVERICK 2 BOW SHACKLE KIT

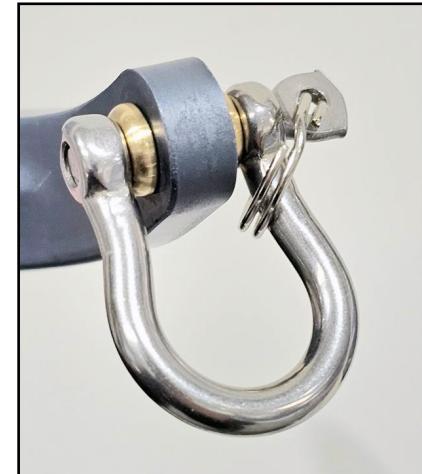
It has been brought to our attention that in some instances, the soft link attachment on the Maverick 2 harness arm can become damaged/frayed, and in extreme cases, through continued use, can snap.

We would like to remind all pilots of the importance of a comprehensive pre and post flight inspection of your equipment. It is our recommendation that pilots add the inspection of the soft link connection to the pre-flight check list, inspecting for any signs of abrasion or fraying. If any abrasion or fraying is apparent, we strongly advise immediate retiring of the compromised soft links.

Furthermore, we are pleased to advise that the option of a Bow Shackle Adaptor Kit for the Maverick 2 Harness Arm is now available. To discuss further, please contact us at info@parajet.com
