PARAJET SAFETY ADVISORY BULLETIN

AUGUST 2024 - MAV MAX 12.5L FUEL TANK

Parajet 12.5L Fuel Tank [PJ-A-11655]

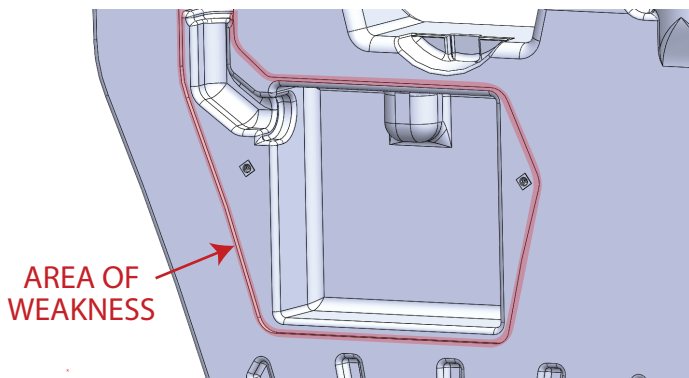
We have received a report of a cracked 12.5L Mav Max fuel tank, specifically around the inset for the battery back plate. Cracking in this area has resulted in fuel seeping when the tank is tilted forwards or filled above the 10L level.

Please take note of the advisory and ensure you monitor the tank in this area prior to and after every flight. Should you experience any issue or be concerned in any way, please do not fly and immediately contact us at info@parajet.com so that we may assess the situation and confirm if we believe the tank is effected and should be replaced.

NB. The 16.5L size fuel tank is not affected by this advisory as several upgrades were made during design process, including a chamfered edge, re-enforcement of material around the plate area, and a newly sized plate to allow for less stress. As a result, any 12.5L tanks effected will be replaced by the larger 16.5L size to ensure customers can have total peace of mind.
